Innovation Park Water

Paulina Hall and Shannon Woolfolk

The Governor's School at Innovation Park

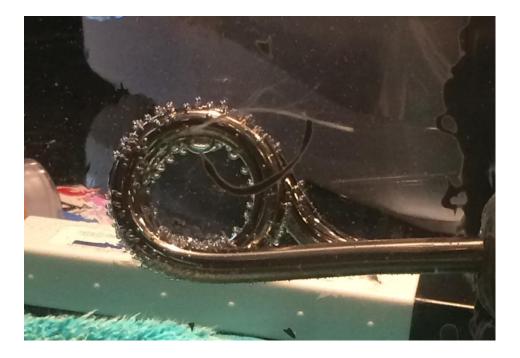
Figure 1: This shows the water heater after one minute of operation. The bubbles on the heater show that the water is heating, not reaching a boiling point yet, but close none the less.

When the first chamber was tested, the initial temperature of the water was 34.5 degrees Celsius. After 12 minutes and 43 seconds of the water heater heating the water, the temperature raised to 52.1 degrees Celsius. Following that trend, the water would heat to boiling temperature within the hour, but this has not been tested yet because the inside of the chamber needs to be resealed with putty, as mentioned in methods. Figure one shows the water on the heater after the first minute and a half of run time.
